**Flood Control Project Maintenance
Levee Inspections**
LMA District Cover Sheet
Spring 2019 Levee Inspection Results

Madera County FCWCA

Spring 2019 Levee Inspection Results

Waterway			Bank	Unit Miles
Unit No. 01 Ash Slough			Right	2.37
	Spring (March - May)	Summer (June - August)	(September - November) Fall	Winter (December - February)
Unit Maintenance Rating (Fall Only)				
Date of Inspection	5/9/2019 - 5/9/2019			
DWR Inspector	Corey Fujitani			
Accompanied By	Dario Dominguez Madera County

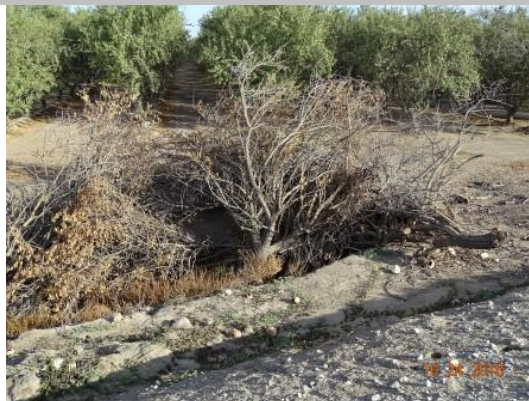
Photo 1 of 1 : SP_2019_NA0011_142_36_20190307_00018.jpg

LM Start	0.04	Rating **	M	Issue No.	36
LM End	0.04	Issue Type +	En	Location *	LS
Category	Earthen Levee			GPS Latitude/Longitude	
				Start	End
Item	Encroachments			37.046589 °	37.046589 °
				-120.427298 °	-120.427298 °
DWR ID	DWR_NA0011_01_s_2012_36				
Comment Code					
PR : Prunings					
Inspector Comment					
Remove the prunings from the landside slope.

View of prunings left on the landside slope. (Fall 2018)

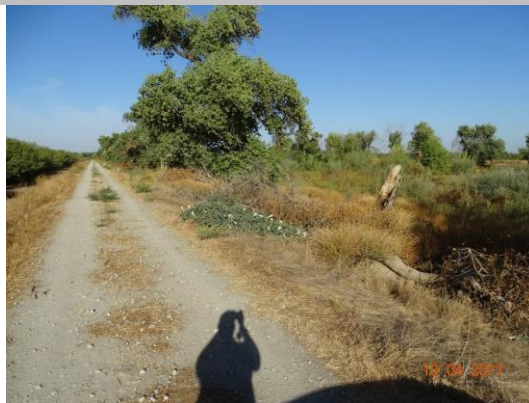
Photo 1 of 1 : SP_2019_NA0011_142_11_20190307_00002.jpg

LM Start	0.44	Rating **	M	Issue No.	11
LM End	0.44	Issue Type +	Ma	Location *	WS
Category	Earthen Levee			GPS Latitude/Longitude	
				Start	End
Item	Encroachments			37.049455 °	37.049455 °
				-120.421218 °	-120.421218 °
DWR ID	DWR_NA0011_01_s_2012_11				
Comment Code					
TR : Tree or limb					
Inspector Comment					
Remove the dead tree from the waterside slope.

Remove downed tree from waterside slope.

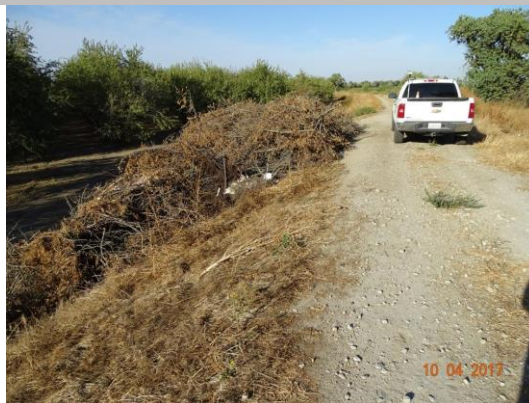
Photo 2 of 2 : SP_2019_NA0011_142_13_20190307_00005.jpg

LM Start	0.59	Rating **	U	Issue No.	13 (cont)	
LM End	0.59	Issue Type +	En	Location *	LS	
Category	Earthen Levee			GPS Latitude/Longitude		
				Start		End
Item	Encroachments			37.050920 °		37.050920 °
				-120.419210 °		-120.419210 °
DWR ID	DWR_NA0011_01_f_2017_13					
Comment Code						
PR : Prunings						
Inspector Comment						
Remove the large pruning piles on landside slope.

Remove large pruning piles from landside slope.

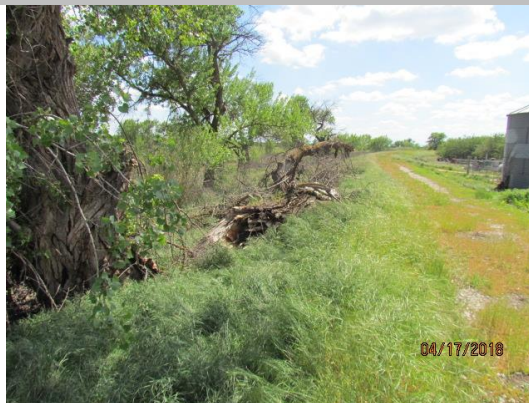
Photo 1 of 1 : SP_2019_NA0011_142_21_20190307_00011.jpg

LM Start	0.75	Rating **	U	Issue No.	21
LM End	0.75	Issue Type +	En	Location *	WS
Category	Earthen Levee			GPS Latitude/Longitude	
				Start	End
Item	Encroachments			37.052796 °	37.052796 °
				-120.417641 °	-120.417640 °
DWR ID	DWR_NA0011_01_f_2017_21				
Comment Code					
TR : Tree or limb					
Inspector Comment					
Remove tree limbs from waterside slope.

Looking west at tree limbs and branches on waterward slope. (Spring 2018)

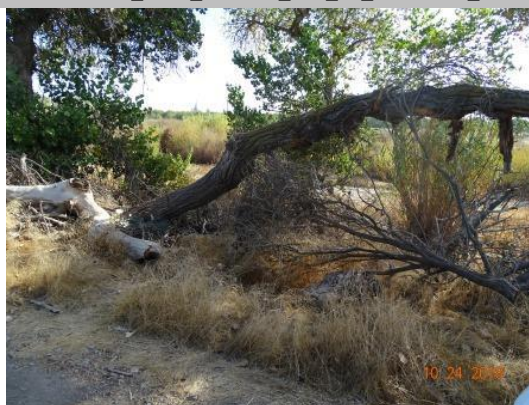
Photo 1 of 1 : SP_2019_NA0011_142_25_20190307_00013.jpg

LM Start	0.79	Rating **	U	Issue No.	25
LM End	0.79	Issue Type +	En	Location *	WS
Category	Earthen Levee			GPS Latitude/Longitude	
				Start	End
Item	Encroachments			37.053329 °	37.053329 °
				-120.417448 °	-120.417448 °
DWR ID	DWR_NA0011_01_f_2018_25				
Comment Code					
TR : Tree or limb					
Inspector Comment					
fallen tree blocking waterside slope

tree limbs and trunks on waterside shoulder and slope. (Fall 2018)

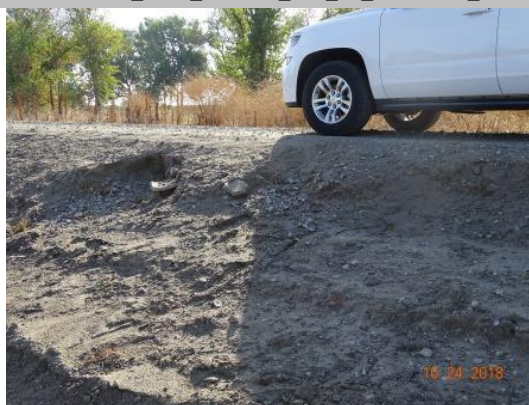
Photo 2 of 2 : SP_2019_NA0011_142_29_20190307_00016.jpg

LM Start	1.04	Rating **	M	Issue No.	29 (cont)
LM End	1.04	Issue Type +	Ma	Location *	LS

Erosion on landside slope. (Fall 2018)

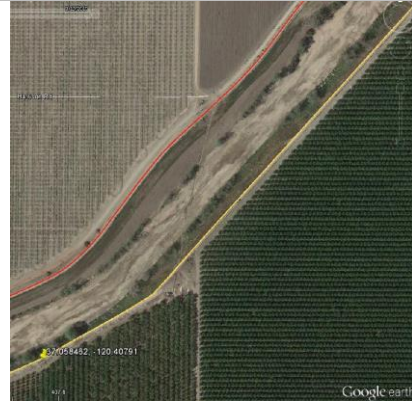
Photo 1 of 3 : UCIP_SP_2019_53155_75206.jpg

FS_ID:53155
DS_ID:25456
EP_NO: N/A
Repair Type: Non-Urgent
Crossing Status: Found
UCIP Comments: 10/31/2018 Pipe has been capped off. No integrity issues were observed during the site inspection. Crossing has been downgraded from Urgent to Non-Urgent. Need to coordinate with the CVFPB to determine if the unauthorized crossing will need to be removed, pending issue that needs to be resolved. (O. Magana - DWR UCIP)
07/14/2016 Open pipe still remains on WS through short levee. Need to contact owner to determine extent of work completed through section of levee. (DWR UCIP - omagana)
06/14/2016 Levee disturbed without prior authorization, it appears that the pipe owner did not notify CVFPB of the construction activity. Crossing was added to UCIP database. Spoke to Herman Phillips (DWR Levee Inspector) regarding unauthorized pipe installation along LS toe of U2. The LS toe of U2 (approximately 731 feet) was disturbed. DWR Inspector mentioned that Dario Dominguez with Madera County Flood Control, LMA representative, has sent the pipe owner notification of unauthorized excavation to replace existing pipe along U2 LS toe, dated May 5, 2016. After reviewing the timed aerial photographs (aerials) under Google Earth a new discovery was made regarding the extend of the area disturbed. Based on the aerials it appears that the new pipe system goes through U1 and U2 levees, across Ash Slough, and along LS toe of U2. The pipe through the levees and channel appears to tie into the work currently being done on the LS toe of U2. Both U1 and U2 levees appear to have been disturbed during 2014-2015. The aerials show that the crossing was not present in the aerial dated 4/5/2014, crossing was not present during the 2014 UCIP Inspection dated 5/6/2014, and the crossing was present in the aerial dated 3/18/2015. According to DWR Inspector, Dario Dominguez with Madera County Flood Control was notified of the additional unauthorized encroachment issue (unauthorized work completed in 2014-2015 on both levees and the channel) that could be related to the trench work being completed by Mr. Sterling. (DWR UCIP - omagana)

FIELD_STRUCT_DESC: *ILLEGAL ENCROACHMENT* 10-inch to 12-inch irrigation siphon pipe of an unknown material through both levees and across the channel, at an unknown depth. The pipe starts on the landside (LS) toe of Unit 1 (U1) and continues across the channel and through the Unit 2 (U2) levee. The pipe then runs along the LS toe of U2 for approximately 731 feet. This crossing was field discovered. The owner of this crossing is Michael Alexander Sterling, 19140 Faralton Road, Madera, CA 93638-0313.
FS Date: 10/31/2018 11:26:00 AM

Aerial photo of Encroachment visible through levee and channel in 2015.
(Source: Google Earth, 3/18/2015)

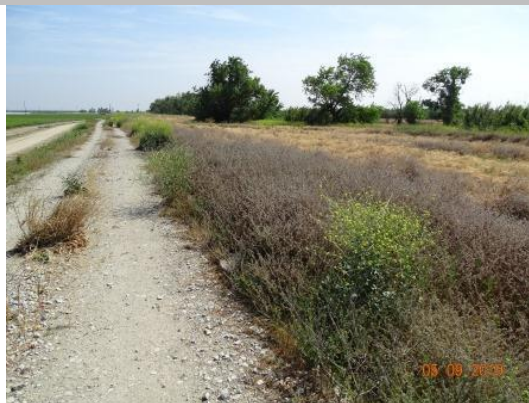
Photo 1 of 1 : SP_2019_NA0011_142_33_20190513_00035.jpg

LM Start	1.73	Rating **	U	Issue No.	33
LM End	2.35	Issue Type +	Ma	Location *	WS
Category	Earthen Levee			GPS Latitude/Longitude	
				Start	End
Item	Vegetation			37.061654 °	37.068526 °
				-120.405154 °	-120.398645 °
DWR ID	DWR_NA0011_01_s_2019_33				
Comment Code					
V1 : Control annual grass and weeds on the levee slopes and easements.					
Inspector Comment

View of waterside slope looking upstream. (Spring 2019)

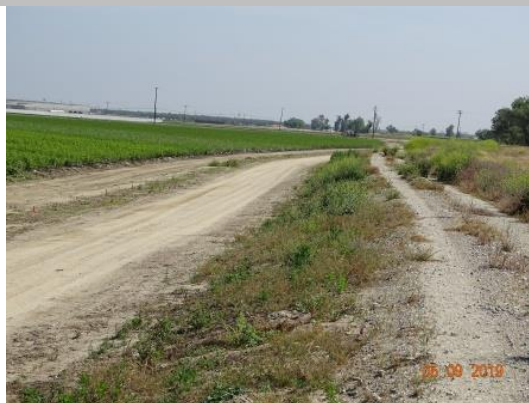
Photo 1 of 1 : SP_2019_NA0011_142_34_20190513_00036.jpg

LM Start	1.75	Rating **	M	Issue No.	34
LM End	1.84	Issue Type +	Ma	Location *	LS
Category	Earthen Levee			GPS Latitude/Longitude	
				Start	End
Item	Vegetation			37.061913 °	37.062881 °
				-120.404827 °	-120.403836 °
DWR ID	DWR_NA0011_01_s_2019_34				
Comment Code					
V1 : Control annual grass and weeds on the levee slopes and easements.					
Inspector Comment

View along landside slope looking upstream. (Spring 2019)

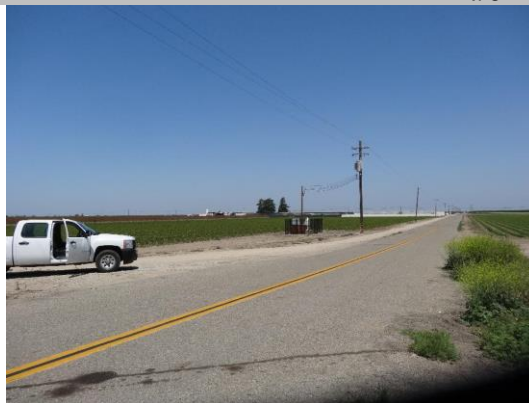
Photo 1 of 3 : UCIP_SP_2019_52847_71800.jpg

LM Start	2.10	Rating **	M	Issue No.	48
LM End	2.10	Issue Type +	En	Location *	
Category	Supplemental			GPS Latitude/Longitude	
				Start	End
Item	DWR UCIP Field Study			37.065649 °	37.065649 °
				-120.400663 °	-120.400663 °
DWR ID	25042				
Comment Code					
Inspector Comment					
FS_ID:52847 DS_ID:25042 EP_NO: N/A Repair Type: Non-Urgent Crossing Status: Found UCIP Comments: 05/06/2014 Need to contact owner to determine if crossing goes through levee. (DWR UCIP - O. Magana) FIELD_STRUCT_DESC: 10-inch or 12-inch drainage discharge pipe of an unknown material through the levee, at an unknown depth. Crossing visible inside a concrete standpipe on the waterside (WS). Potential pump station on the landside (LS), approximately 100 feet from the standpipe. This crossing was field discovered. FS Date: 5/6/2014

Pump station visible approximately 100 feet from concrete standpipe.

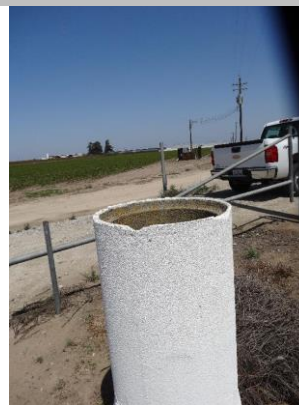
Photo 2 of 3 : UCIP_SP_2019_52847_71803.jpg

Standpipe visible on waterward side.

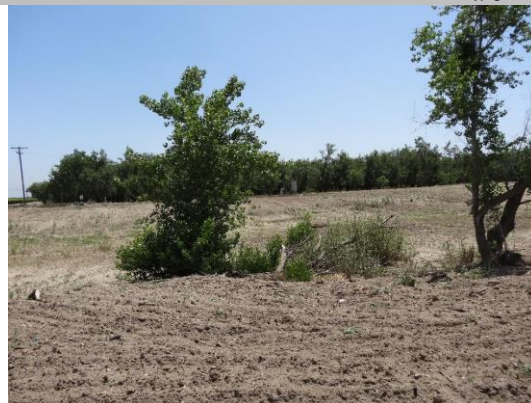
Photo 1 of 3 : UCIP_SP_2019_52848_69679.jpg

LM Start	2.37	Rating **	M	Issue No.	49
LM End	2.37	Issue Type +	En	Location *	
Category	Supplemental			GPS Latitude/Longitude	
				Start	End
Item	DWR UCIP Field Study			37.068763 °	37.068763 °
				-120.398523 °	-120.398523 °
DWR ID	21512				
Comment Code					
Inspector Comment					
FS_ID:52848 DS_ID:21512 EP_NO: N/A Repair Type: Non-Urgent Crossing Status: Found UCIP Comments: 05/06/2014 Unable to determine details of crossing and whether crossing has been abandoned. Need to find owner and determine the alignment of crossing to confirm if pipe is being extended from opposite levee. (DWR UCIP - O. Magana) FIELD_STRUCT_DESC: *ABANDONED* Service pole, pump, and two 36-inch standpipes on the landside (LS). Pump not found during 2014 inspection. Three standpipes found on the LS. [Additional Reference(s): DWR Levee Log, 2005]. FS Date: 5/6/2014

View of waterward side.

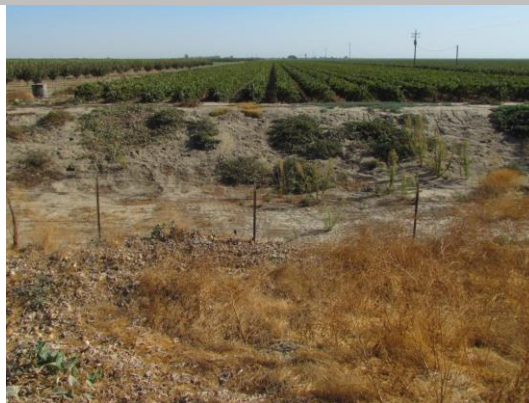
Photo 1 of 1 : SP_2019_NA0011_143_32_20190307_00025.jpg

LM Start	0.00	Rating **	U	Issue No.	32
LM End	0.00	Issue Type +	En	Location *	LS
Category	Earthen Levee			GPS Latitude/Longitude	
				Start	End
Item	Encroachments			37.045539 °	37.045505 °
				-120.427444 °	-120.427473 °
DWR ID	DWR_NA0011_02_f_2012_32				
Comment Code					
DT : Ditch					
Inspector Comment					
There is a settling basin on the landward side of the levee. This basin is very close to the landside easement.

Ash Slough at levee mile 0.01- 0.03. Settling basin on the landside levee berm.

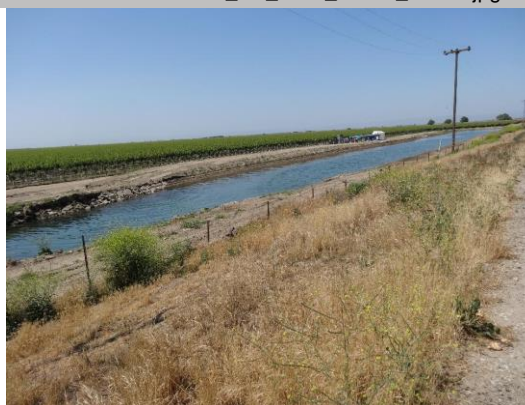
Photo 1 of 3 : UCIP_SP_2019_52830_71662.jpg

LM Start	0.01	Rating **	M	Issue No.	48
LM End	0.01	Issue Type +	En	Location *	
Category	Supplemental			GPS Latitude/Longitude	
				Start	End
Item	DWR UCIP Field Study			37.045532 °	37.045532 °
				-120.427268 °	-120.427268 °
DWR ID	21585				
Comment Code					
Inspector Comment					
FS_ID:52830 DS_ID:21585 EP_NO: 8068 Repair Type: Non-Urgent Crossing Status: Found UCIP Comments: 05/06/2014 Unable to confirm if crossing found in the field corresponds to the crossing described under Permit 8068. Only 1 crossing found permit indicates 2 irrigation culverts. Need to contact owner to obtain additional details of crossing. (DWR UCIP - O. Magana) FIELD_STRUCT_DESC: To retain two irrigation culverts and siphons of an unknown size or material through the levee, at an unknown depth. Located at the intersection of Ash Slough and the Chowchilla Canal. FS Date: 5/6/2014

View of landward side.

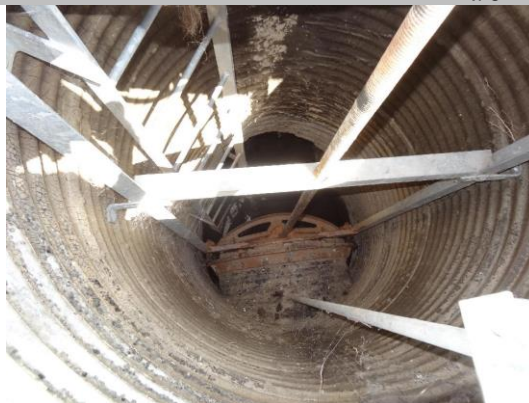
Photo 2 of 3 : UCIP_SP_2019_52830_71661.jpg

View of riser located on waterward side.

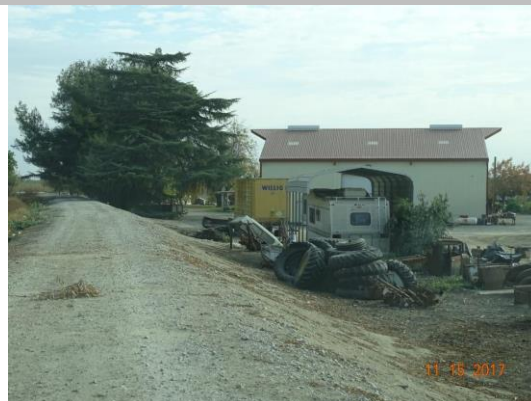
Photo 1 of 1 : SP_2019_NA0011_143_12_20190307_00009.jpg

LM Start	0.09	Rating **	U	Issue No.	12
LM End	0.16	Issue Type +	En	Location *	LS
Category	Earthen Levee			GPS Latitude/Longitude	
				Start	End
Item	Encroachments			37.045876 °	37.046198 °
				-120.425932 °	-120.424737 °
DWR ID	DWR_NA0011_02_f_2017_12				
Comment Code					
EQ : Equipment					
Inspector Comment

Move equipment away from levee slope, toe and 10-foot easement at toe to allow inspection and access.

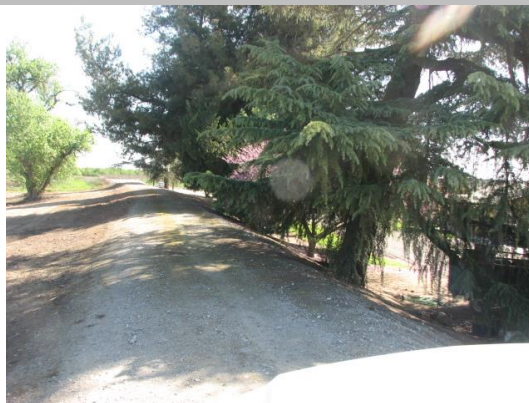
Photo 1 of 1 : SP_2019_NA0011_143_23_20190307_00016.jpg

LM Start	0.16	Rating **	U	Issue No.	23
LM End	0.23	Issue Type +	En	Location *	LS
Category	Earthen Levee			GPS Latitude/Longitude	
				Start	End
Item	Vegetation			37.046240 °	37.046583 °
				-120.424608 °	-120.423560 °
DWR ID	DWR_NA0011_02_s_2017_23				
Comment Code					
V6 : Landscaping					
Inspector Comment					
Trim the tree limbs blocking view of landward levee slope.

Looking downstream at tree on landward slope. (Spring 2018)

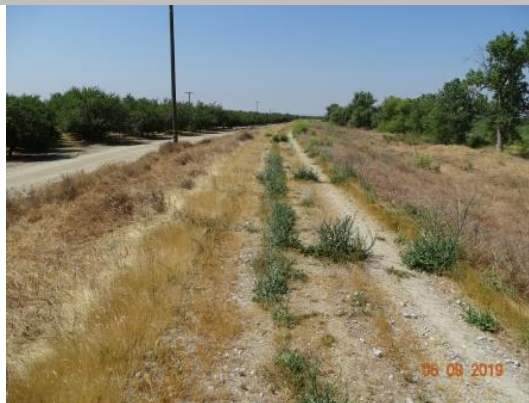
Photo 1 of 1 : SP_2019_NA0011_143_43_20190513_00052.jpg

LM Start	0.23	Rating **	U	Issue No.	43
LM End	0.82	Issue Type +	Ma	Location *	CR
Category	Earthen Levee			GPS Latitude/Longitude	
				Start	End
Item	Vegetation			37.046624 °	37.052794 °
				-120.423496 °	-120.416505 °
DWR ID	DWR_NA0011_02_s_2019_43				
Comment Code					
V9 : Keep the crown roadway free of vegetation.					
Inspector Comment

View of vegetation on levee crown looking downstream. (Spring 2019)

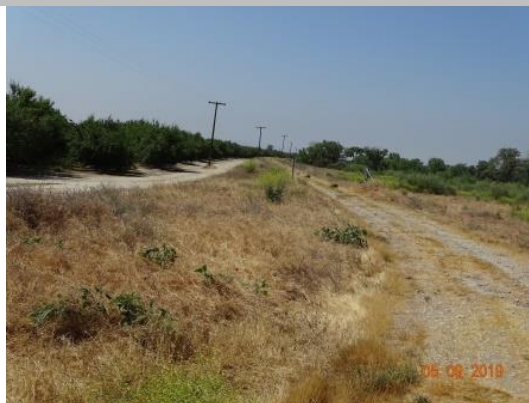
Photo 1 of 1 : SP_2019_NA0011_143_42_20190513_00053.jpg

LM Start	0.23	Rating **	U	Issue No.	42
LM End	0.94	Issue Type +	Ma	Location *	LS
Category	Earthen Levee			GPS Latitude/Longitude	
				Start	End
Item	Vegetation			37.046624 °	37.054441 °
				-120.423496 °	-120.415898 °
DWR ID	DWR_NA0011_02_s_2019_42				
Comment Code					
V1 : Control annual grass and weeds on the levee slopes and easements.					
Inspector Comment

View along landside slope looking downstream. (Spring 2019)

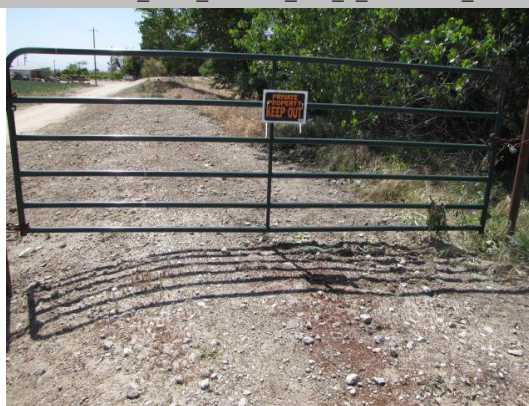
Photo 1 of 2 : SP_2019_NA0011_143_5_20190307_00005.jpg

LM Start	0.30	Rating **	M	Issue No.	5
LM End	0.30	Issue Type +	En	Location *	CR
Category	Earthen Levee			GPS Latitude/Longitude	
				Start	End
Item	Encroachments			37.047100 °	37.047100 °
				-120.422448 °	-120.422448 °
DWR ID	DWR_NA0011_02_f_2012_5				
Comment Code					
FE : Fence					
Inspector Comment					
This fence was not authorized by CVFPB. The District is aware of the fence. The landowner installed the fence and gate across the levee section because he has been broken into frequently and had many items stolen in the past. I met with the landowner 4-29-2014 and he let me put a State lock on his gate to gain access to the levee.

Unauthorized gate and metal fence placed on slope and toe of levee section. Photo taken 4-17-2013.

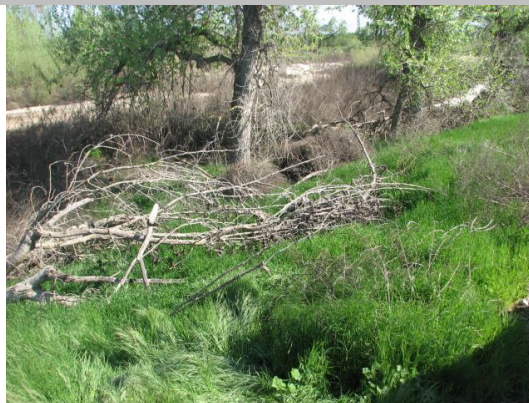
Photo 1 of 1 : SP_2019_NA0011_143_28_20190307_00022.jpg

LM Start	0.32	Rating **	M	Issue No.	28	
LM End	0.32	Issue Type +	Ma	Location *	WS	
Category	Earthen Levee			GPS Latitude/Longitude		
				Start		End
Item	Encroachments			37.047416 °		37.047416 °
				-120.422142 °		-120.422142 °
DWR ID	DWR_NA0011_02_f_2012_28					
Comment Code						
TR : Tree or limb						
Inspector Comment						
Remove the dead tree limbs from the waterside slope.

Looking downstream at tree limbs on waterward slope and toe. (Spring 2018)

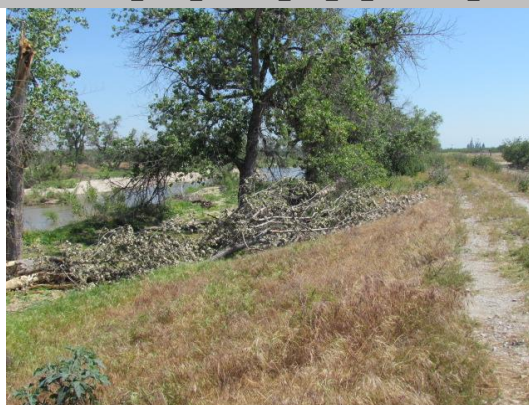
Photo 1 of 1 : SP_2019_NA0011_143_33_20190307_00026.jpg

LM Start	0.33	Rating **	U	Issue No.	33
LM End	0.42	Issue Type +	Ma	Location *	WS
Category	Earthen Levee			GPS Latitude/Longitude	
				Start	End
Item	Encroachments			37.047485 °	37.048403 °
				-120.422037 °	-120.420810 °
DWR ID	DWR_NA0011_02_s_2017_33				
Comment Code					
TR : Tree or limb					
Inspector Comment					
Remove the dead fallen trees from the water side slope.

Dead fallen trees on the waterside levee slope and shoulder.

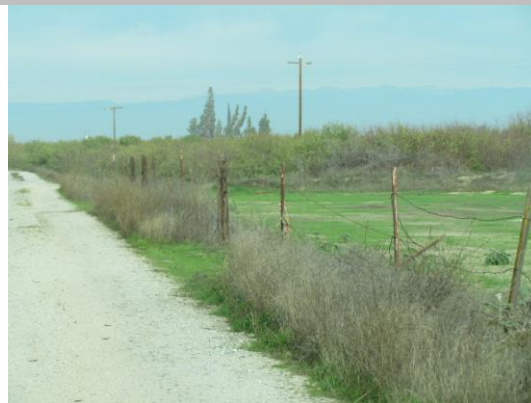
Photo 1 of 1 : SP_2019_NA0011_143_11_20190307_00008.jpg

LM Start	0.45	Rating **	M	Issue No.	11
LM End	0.53	Issue Type +	En	Location *	LS
Category	Earthen Levee			GPS Latitude/Longitude	
				Start	End
Item	Encroachments			37.048627 °	37.049342 °
				-120.420357 °	-120.419370 °
DWR ID	DWR_NA0011_02_s_2012_11				
Comment Code					
FE : Fence					
Inspector Comment					
Wire fence on the landside levee shoulder along with unwanted tall weed growth..

Fence on the landside slope.

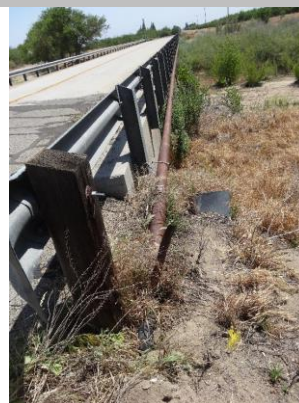
Photo 2 of 3 : UCIP_SP_2019_52839_71822.jpg

LM Start	0.94	Rating **	M	Issue No.	50
LM End	0.94	Issue Type +	En	Location *	
Category	Supplemental			GPS Latitude/Longitude	
				Start	End
Item	DWR UCIP Field Study			37.054547 °	37.054547 °
				-120.415826 °	-120.415826 °
DWR ID	25043				
Comment Code					
Inspector Comment					
FS_ID:52839					
DS_ID:25043					
EP_NO: N/A					
Repair Type: Non-Urgent					
Crossing Status: Found					
UCIP Comments: 05/06/2014 Need to contact owner to determine status. Need permit authorizing work. (DWR UCIP - O. Magana)					
FIELD_STRUCT_DESC: 5-inch steel communications conduit along the downstream face of the bridge. The upstream face has a 2-inch pipe cut at the corner. This crossing was field discovered.					
FS Date: 5/6/2014

View of steel conduit through levee and above channel.

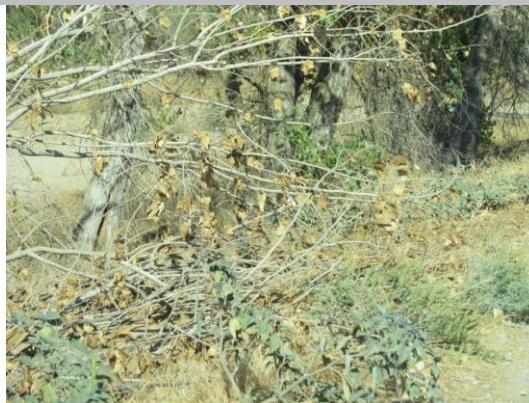
Photo 1 of 2 : SP_2019_NA0011_143_27_20190307_00020.jpg

LM Start	0.98	Rating **	U	Issue No.	27 (cont)
LM End	1.52	Issue Type +	Ma	Location *	WS

Levee slope and shoulder looking upstream waterside levee section.

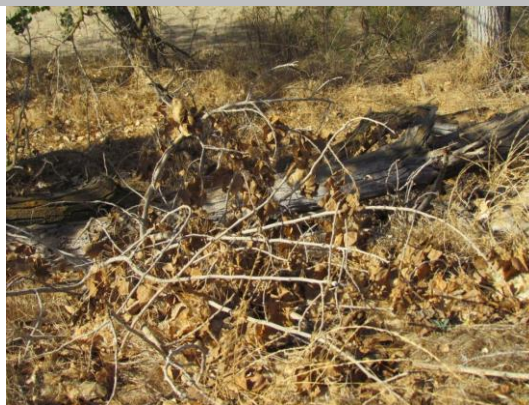
Photo 2 of 2 : SP_2019_NA0011_143_27_20190307_00021.jpg

Unit 2 Ash Slough Levee mile 0.98 waterside shoulder and slope

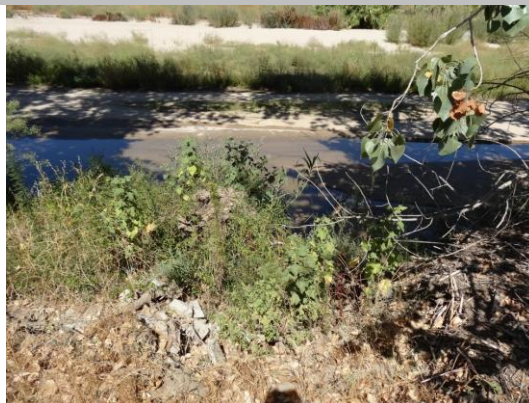
Photo 1 of 4 : SP_2019_NA0011_143_1_20190307_00001.jpg

Comment Code					
Inspector Comment					
09/20/2017: No significant change observed. 07/22/2016: No significant change observed. 09/08/2015: No significant change observed. 07/22/2014: No significant change observed. 08/30/2013: No significant change observed. 07/31/2012: Site was visited on 07/24/2012. No significant change observed. Dense vegetation around the site 08/09/2011: Site was inspected. No visible change was observed from the previous condition. A fallen tree was seen at the levee toe about 20 feet upstream, and tree root exposed. There has been no report from the district that this site was corrected. 11/30/2010: Site was not inspected due to time constraints. There have been no reports from the district that the site was corrected. Continue to monitor site during flood events. 08/05/2010: Recommended for annual assessment and monitoring during flood events, per CLRO. 2009: Site is recommended as a local maintenance issue, per Critical Levee Repair Office, Critical Erosion Sites Evaluation 2008 Report; site was previously rated "M" 9/6/2007: Undercutting of the toe; several trees along the WS slope with roots exposed. [2017 Site ID:NA0011U02RM2.57]

View of the erosion site from the levee crest.

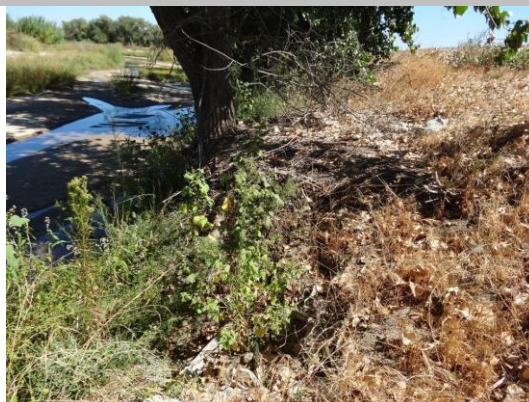
Photo 2 of 4 : SP_2019_NA0011_143_1_20190307_00002.jpg

Close view of the site.

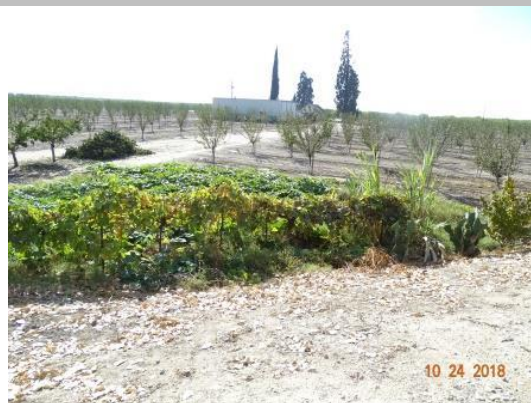
Photo 1 of 3 : SP_2019_NA0011_143_18_20190307_00013.jpg

LM Start	1.24	Rating **	M	Issue No.	18
LM End	1.24	Issue Type +	En	Location *	LS
Category	Earthen Levee			GPS Latitude/Longitude	
				Start	End
Item	Encroachments			37.056226 °	37.056226 °
				-120.411066 °	-120.411066 °
DWR ID	DWR_NA0011_02_f_2017_18				
Comment Code					
LI : Landscape Irrigation					
Inspector Comment					
Landowner removed most of the landscaping except for cactus and grapevines planted at landward toe.

Grape vines, landscaping vegetation, and cactus. (Fall 2018)

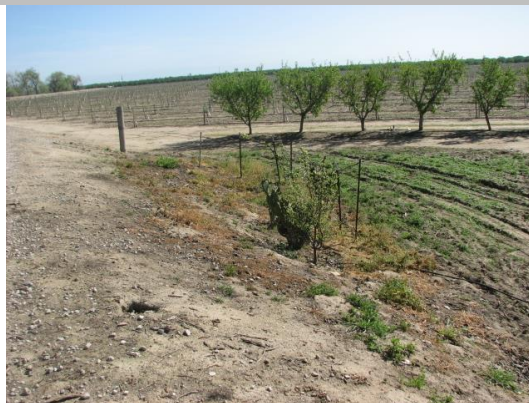
Photo 3 of 3 : SP_2019_NA0011_143_18_20190307_00015.jpg

LM Start	1.24	Rating **	M	Issue No.	18 (cont)	
LM End	1.24	Issue Type +	En	Location *	LS	
Category	Earthen Levee			GPS Latitude/Longitude		
				Start		End
Item	Encroachments			37.056226 °		37.056226 °
				-120.411066 °		-120.411066 °
DWR ID	DWR_NA0011_02_f_2017_18					
Comment Code						
LI : Landscape Irrigation						
Inspector Comment						
Landowner removed most of the landscaping except for cactus and grapevines planted at landward toe.

Looking downstream at cactus on landward toe. (Spring 2018)

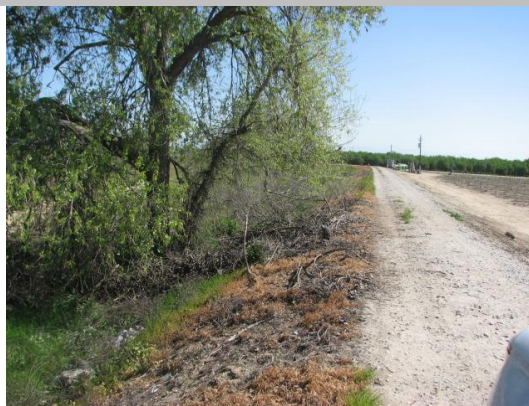
Photo 1 of 1 : SP_2019_NA0011_143_25_20190307_00019.jpg

LM Start	1.51	Rating **	M	Issue No.	25
LM End	1.52	Issue Type +	Ma	Location *	WS
Category	Earthen Levee			GPS Latitude/Longitude	
				Start	End
Item	Trim / Thin Trees			37.058652 °	37.058802 °
				-120.407638 °	-120.407350 °
DWR ID	DWR_NA0011_02_s_2012_25				
Comment Code					
T4 : Trim trees over roadway to at least 12 feet above ground level.					
Inspector Comment					
Trim the trees on the waterside slope levee miles 1.51-1.52.

Look downstream at untrimmed tree on waterward slope. (Spring 2018)

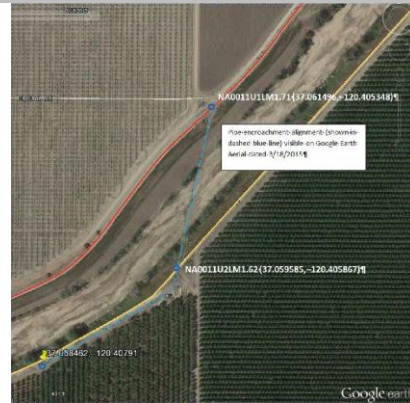
Photo 1 of 3 : UCIP_SP_2019_52842_75220.jpg

Comment Code					
Inspector Comment					
FS_ID:52842 DS_ID:25457 EP_NO: N/A Repair Type: Non-Urgent Crossing Status: Found UCIP Comments: 7/14/2016 Repair in progress--According to LMA representative, Dario Dominguez, owner has repaired levee slope and compacted material per CVFPB's requirement (compaction tests have been performed). Need to confirm compaction tests were provided to DWR Inspector-Herman Phillips. (DWR UCIP - omagana)6/14/2016 Levee disturbed without prior authorization, it appears that the pipe owner did not notify CVFPB of the construction activity. Crossing was added to UCIP database. Spoke to Herman Phillips (DWR Levee Inspector) regarding unauthorized pipe installation along LS toe of U2. The LS toe of U2 (approximately 731 feet) was disturbed. DWR Inspector mentioned that Dario Dominguez with Madera County Flood Control, LMA representative, has sent the pipe owner notification of unauthorized excavation to replace existing pipe along U2 LS toe, dated May 5, 2016. After reviewing the timed aerial photographs (aerials) under Google Earth a new discovery was made regarding the extend of the area disturbed. Based on the aerials it appears that the new pipe system goes through U1 and U2 levees, across Ash Slough, and along LS toe of U2. The pipe through the levees and channel appears to tie into the work currently being done on the LS toe of U2. Both U1 and U2 levees appear to have been disturbed during 2014-2015. The aerials show that the crossing was not present in the aerial dated 4/5/2014, crossing was not present during the 2014 UCIP Inspection dated 5/6/2014, and the crossing was present in the aerial dated 3/18/2015. According to DWR Inspector, Dario Dominguez with Madera County Flood Control was notified of the additional unauthorized encroachment issue (unauthorized work completed in 2014-2015 on both levees and the channel) that could be related to the trench work being completed by Mr. Sterling. (DWR UCIP - omagana) FIELD_STRUCT_DESC: *ILLEGAL ENCROACHMENT* 10-inch to 12-inch irrigation siphon pipe of an unknown material through both levees and across the channel, at an unknown depth. The pipe starts on the landside (LS) toe of Unit 1 (U1) and continues across the channel and through the Unit 2 (U2) levee. The pipe then runs along the LS toe of U2 for approximately 731 feet. The pipe along the LS toe of U2 starts at 37.059237, -120.406025, and ends at 37.058462, -120.40791. This crossing was field discovered. FS Date: 7/14/2016

Assumed alignment of pipe through the levees and along LS toe of Unit 2. (Source: Google Earth, 3/18/2015)

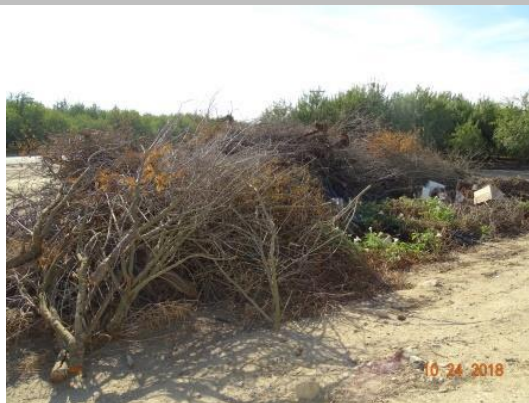
Photo 1 of 2 : SP_2019_NA0011_143_24_20190307_00017.jpg

LM Start	2.00	Rating **	U	Issue No.	24
LM End	2.00	Issue Type +	En	Location *	LS
Category	Earthen Levee			GPS Latitude/Longitude	
				Start	End
Item	Encroachments			37.063642 °	37.063642 °
				-120.401434 °	-120.401434 °
DWR ID	DWR_NA0011_02_f_2017_24				
Comment Code					
PR : Prunings					
Inspector Comment					
Large pruning/burn pile may be intermittent issue, but should be located away from levee toe.

Move pruning pile to allow 10 ft easement from levee toe. (Fall 2018)

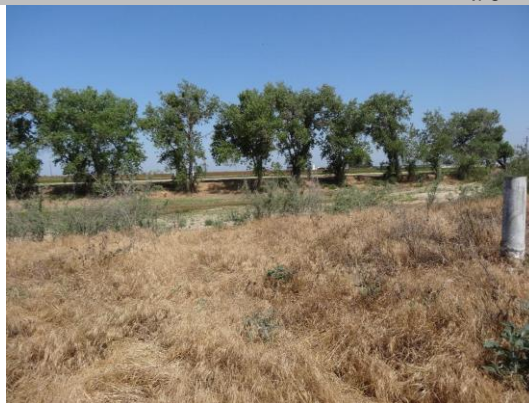
Photo 3 of 3 : UCIP_SP_2019_52844_71819.jpg

LM Start	2.02	Rating **	M	Issue No.	52 (cont)	
LM End	2.02	Issue Type +	En	Location *		
Category	Supplemental			GPS Latitude/Longitude		
				Start	End	
Item	DWR UCIP Field Study			37.063982 °	37.063982 °	
				-120.401165 °	-120.401165 °	
DWR ID	25045					
Comment Code						
Inspector Comment						
FS_ID:52844 DS_ID:25045 EP_NO: N/A Repair Type: Non-Urgent Crossing Status: Indicator Found UCIP Comments: 05/06/2014 Need to contact owner to determine additional information about crossing and potential appurtenances. (DWR UCIP - O. Magana) FIELD_STRUCT_DESC: *ABANDONED* 36-inch pipe of an unknown material or purpose through the levee, at an unknown depth. The pipe is filled with concrete. This crossing was field discovered. FS Date: 5/6/2014

View of waterward side.

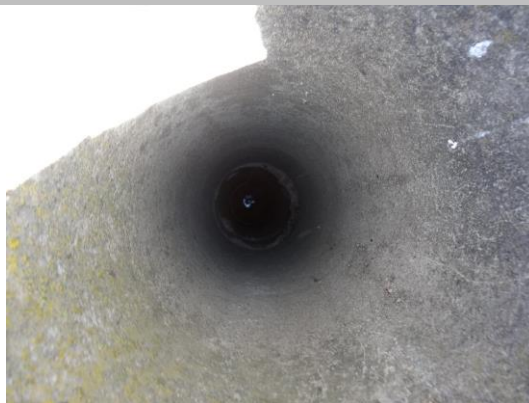
Photo 3 of 3 : UCIP_SP_2019_52845_71807.jpg

LM Start	2.03	Rating **	M	Issue No.	53 (cont)	
LM End	2.03	Issue Type +	En	Location *		
Category	Supplemental			GPS Latitude/Longitude		
				Start	End	
Item	DWR UCIP Field Study			37.064087 °	37.064087 °	
				-120.401194 °	-120.401194 °	
DWR ID	25044					
Comment Code						
Inspector Comment						
FS_ID:52845						
DS_ID:25044						
EP_NO: N/A						
Repair Type: Non-Urgent						
Crossing Status: Found						
UCIP Comments: 05/06/2014 Need to contact owner to determine status. (DWR UCIP - O. Magana)						
FIELD_STRUCT_DESC: 10-inch pipes located on waterside (WS).						
Unsure if these pipes go through the levee. These pipes were field discovered.						
FS Date: 5/6/2014

Inside view of 10-inch concrete standpipe.

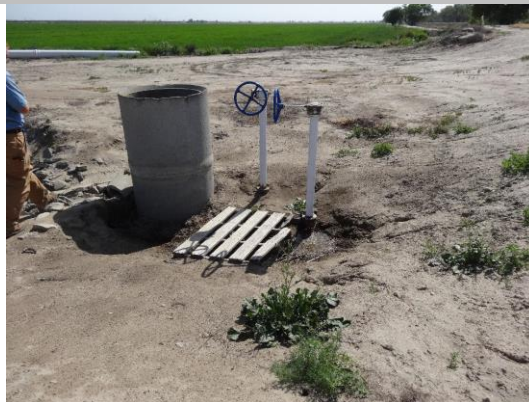
Photo 2 of 3 : UCIP_SP_2019_52829_64475.jpg

LM Start	0.00	Rating **	M	Issue No.	36
LM End	0.00	Issue Type +	En	Location *	
Category	Supplemental			GPS Latitude/Longitude	
				Start	End
Item	DWR UCIP Field Study			36.996593 °	36.996593 °
				-120.373636 °	-120.373636 °
DWR ID	21516				
Comment Code					
Inspector Comment					
FS_ID:52829 DS_ID:21516 EP_NO: N/A Repair Type: Non-Urgent Crossing Status: Found UCIP Comments: 05/06/2014 Unable to confirm if crossing is still being used. Need to contact owner to determine status of crossing. (DWR UCIP - O. Magana) FIELD_STRUCT_DESC: 18-inch steel irrigation discharge pipe through the levee, at an unknown depth. Slant pump on the waterside (WS) slope. The levee log indicates that the abandonment of the Chowchilla Canal Siphon was backfilled through the levee section. [Additional Reference(s): DWR Levee Log, 2005]. FS Date: 5/6/2014

Close up of concrete standpipe and multiple positive closure devices.

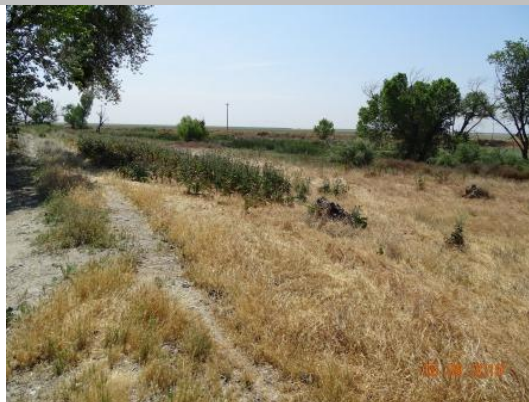
Photo 1 of 1 : SP_2019_NA0011_144_13_20190514_00029.jpg

LM Start	0.01	Rating **	U	Issue No.	13
LM End	1.51	Issue Type +	Ma	Location *	WS
Category	Earthen Levee			GPS Latitude/Longitude	
				Start	End
Item	Vegetation			36.996594 °	36.996602 °
				-120.373546 °	-120.346627 °
DWR ID	DWR_NA0011_03_s_2019_13				
Comment Code					
V1 : Control annual grass and weeds on the levee slopes and easements.					
Inspector Comment

View of waterside slope looking upstream. (Spring 2019)

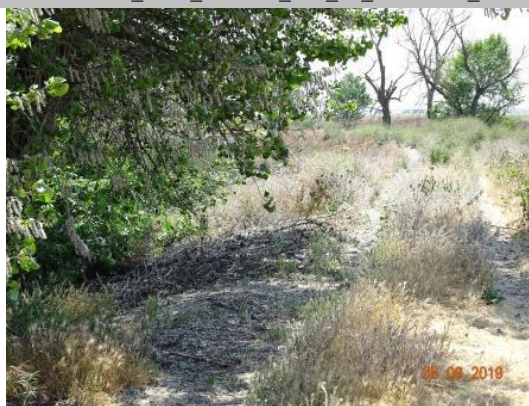
Photo 1 of 1 : SP_2019_NA0011_144_16_20190514_00031.jpg

LM Start	0.04	Rating **	U	Issue No.	16
LM End	1.51	Issue Type +	Ma	Location *	LS
Category	Earthen Levee			GPS Latitude/Longitude	
				Start	End
Item	Vegetation			36.996520 °	36.996602 °
				-120.373013 °	-120.346627 °
DWR ID	DWR_NA0011_03_s_2019_16				
Comment Code					
V1 : Control annual grass and weeds on the levee slopes and easements.					
Inspector Comment

View of vegetation on the landside slope looking upstream. (Spring 2019)

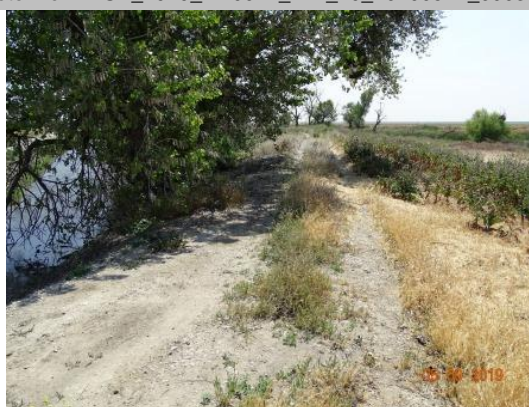
Photo 1 of 1 : SP_2019_NA0011_144_19_20190514_00030.jpg

LM Start	0.04	Rating **	U	Issue No.	19
LM End	1.51	Issue Type +	Ma	Location *	CR
Category	Earthen Levee			GPS Latitude/Longitude	
				Start	End
Item	Vegetation			36.996520 °	36.996602 °
				-120.373013 °	-120.346627 °
DWR ID	DWR_NA0011_03_s_2019_19				
Comment Code					
V9 : Keep the crown roadway free of vegetation.					
Inspector Comment					
Keep the crown roadway free of vegetation.

View of vegetation on levee crown looking upstream. (Spring 2019)

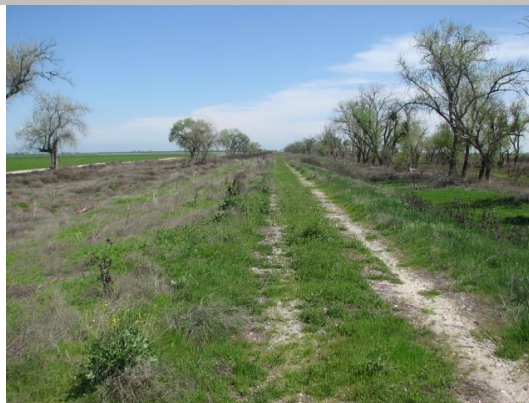
Photo 1 of 1 : SP_2019_NA0011_144_32_20190307_00021.jpg

LM Start	0.08	Rating **	M	Issue No.	32
LM End	1.51	Issue Type +	Ma	Location *	CR
Category	Earthen Levee			GPS Latitude/Longitude	
				Start	End
Item	Crown Surface / Depressions / Rutting			36.996264 °	36.996613 °
				-120.372350 °	-120.346570 °
DWR ID	DWR_NA0011_03_s_2014_32				
Comment Code					
C3 : Add appropriate gravel or road base. Grade and compact.					
Inspector Comment					
Regrade the crown for proper drainage and add more rock to crown.

Looking downstream at levee crown. (Spring 2018)

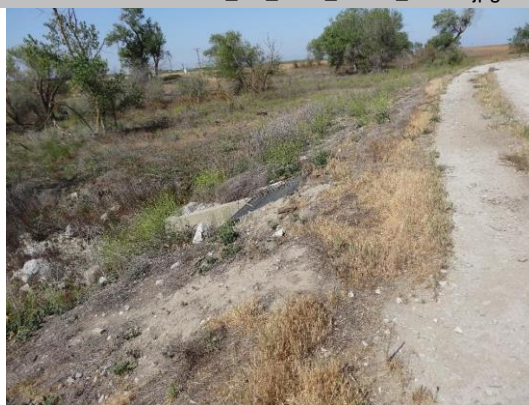
Photo 1 of 3 : UCIP_SP_2019_52832_69689.jpg

LM Start	0.10	Rating **	M	Issue No.	37
LM End	0.10	Issue Type +	En	Location *	
Category	Supplemental			GPS Latitude/Longitude	
				Start	End
Item	DWR UCIP Field Study			36.996177 °	36.996177 °
				-120.371967 °	-120.371967 °
DWR ID	21517				
Comment Code					
Inspector Comment					
FS_ID:52832 DS_ID:21517 EP_NO: N/A Repair Type: Non-Urgent Crossing Status: Found UCIP Comments: 05/06/2014 Need to contact owner to determine status of crossing. Unable to determine if crossing is in use. (DWR UCIP - O. Magana) FIELD_STRUCT_DESC: 36-inch corrugated metal gravity drainage pipe through the levee, 7.3 feet below the crown. Headwall and wing wall on each end. Flap gate on the waterside (WS) end. [Additional Reference(s): DWR Levee Log, 2005]. FS Date: 5/6/2014

View of waterward side.

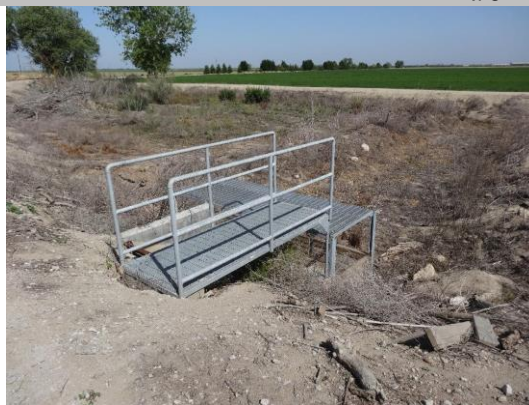
Photo 3 of 3 : UCIP_SP_2019_52832_69688.jpg

LM Start	0.10	Rating **	M	Issue No.	37 (cont)	
LM End	0.10	Issue Type +	En	Location *		
Category	Supplemental			GPS Latitude/Longitude		
				Start	End	
Item	DWR UCIP Field Study			36.996177 °	36.996177 °	
				-120.371967 °	-120.371967 °	
DWR ID	21517					
Comment Code						
Inspector Comment						
FS_ID:52832 DS_ID:21517 EP_NO: N/A Repair Type: Non-Urgent Crossing Status: Found UCIP Comments: 05/06/2014 Need to contact owner to determine status of crossing. Unable to determine if crossing is in use. (DWR UCIP - O. Magana) FIELD_STRUCT_DESC: 36-inch corrugated metal gravity drainage pipe through the levee, 7.3 feet below the crown. Headwall and wing wall on each end. Flap gate on the waterside (WS) end. [Additional Reference(s): DWR Levee Log, 2005]. FS Date: 5/6/2014

View of landward side.

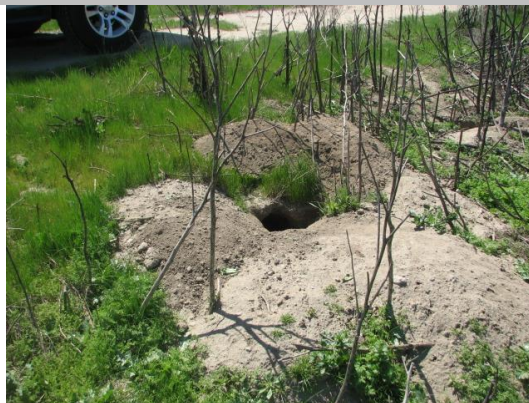
Photo 1 of 6 : SP_2019_NA0011_144_6_20190307_00005.jpg

LM Start	0.40	Rating **	U	Issue No.	6 (cont)
LM End	1.51	Issue Type +	Ma	Location *	LS

Looking at rodent hole on landward slope. (Spring 2018)

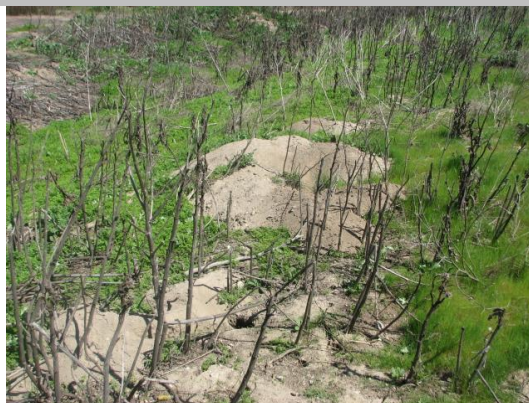
Photo 2 of 6 : SP_2019_NA0011_144_6_20190307_00006.jpg

Looking at typical rodent holes within this section (Spring 2018)

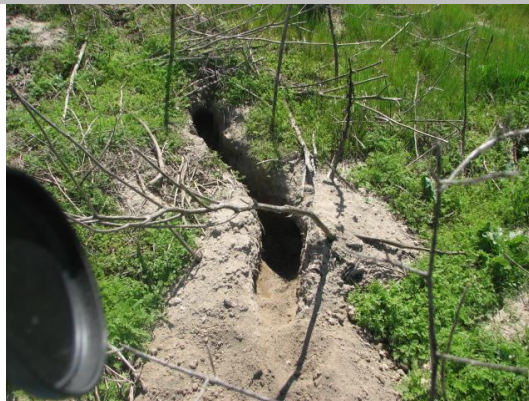
Photo 3 of 6 : SP_2019_NA0011_144_6_20190307_00007.jpg

LM Start	0.40	Rating **	U	Issue No.	6 (cont)
LM End	1.51	Issue Type +	Ma	Location *	LS

Looking at rodent hole on landward slope. (Spring 2018)

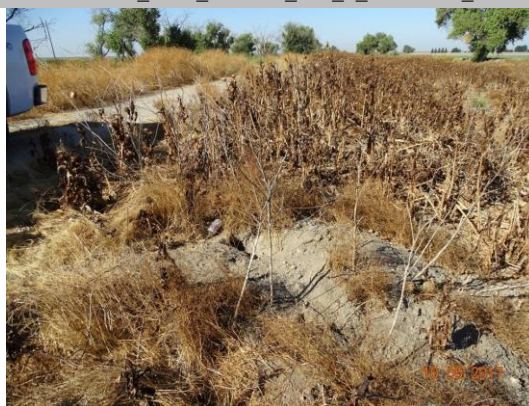
Photo 4 of 6 : SP_2019_NA0011_144_6_20190307_00008.jpg

LM Start	0.40	Rating **	U	Issue No.	6 (cont)
LM End	1.51	Issue Type +	Ma	Location *	LS

Continued rodent activity.

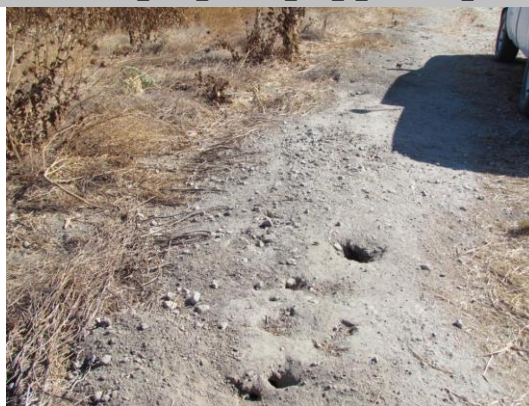
Photo 6 of 6 : SP_2019_NA0011_144_6_20190307_00010.jpg

LM Start	0.40	Rating **	U	Issue No.	6 (cont)
LM End	1.51	Issue Type +	Ma	Location *	LS

Berenda Slough Unit 3 landside shoulder and slope.

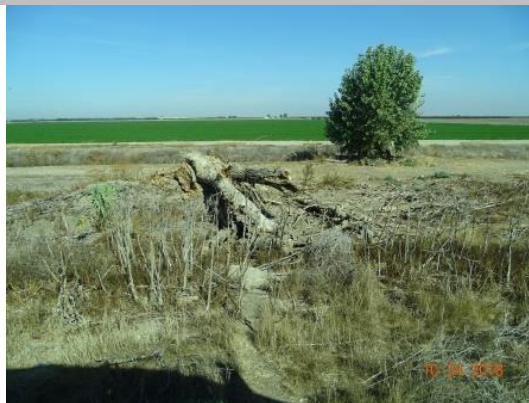
Photo 1 of 1 : SP_2019_NA0011_144_10_20190307_00014.jpg

LM Start	0.45	Rating **	U	Issue No.	10
LM End	0.45	Issue Type +	Ma	Location *	LS
Category	Earthen Levee			GPS Latitude/Longitude	
				Start	End
Item	Encroachments			36.996224 °	36.996224 °
				-120.365692 °	-120.365692 °
DWR ID	DWR_NA0011_03_f_2018_10				
Comment Code					
TR : Tree or limb					
Inspector Comment					
Remove the dead tree from the landside slope.

View of dead tree on the landside slope. (Fall 2018)

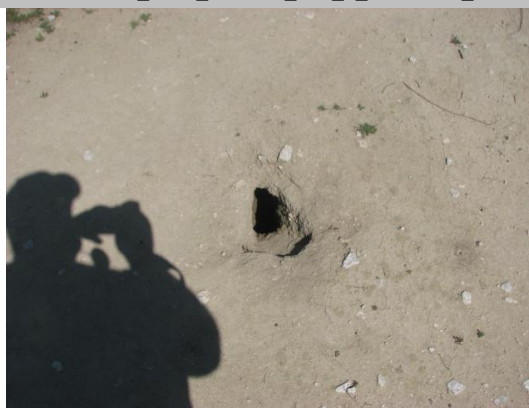
Photo 1 of 1 : SP_2019_NA0011_144_5_20190307_00004.jpg

LM Start	0.46	Rating **	U	Issue No.	5
LM End	0.46	Issue Type +	Ma	Location *	CR
Category	Earthen Levee			GPS Latitude/Longitude	
				Start	End
Item	Animal Control			36.996238 °	36.996238 °
				-120.365563 °	-120.365563 °
DWR ID	DWR_NA0011_03_s_2018_5				
Comment Code					
A3 : No rodents visible, but rodent burrows visible; need to backfill and compact or grout burrows.					
Inspector Comment					
There is a large rodent hole on the crown of the levee.

Looking at rodent hole on levee crown. (Spring 2018)

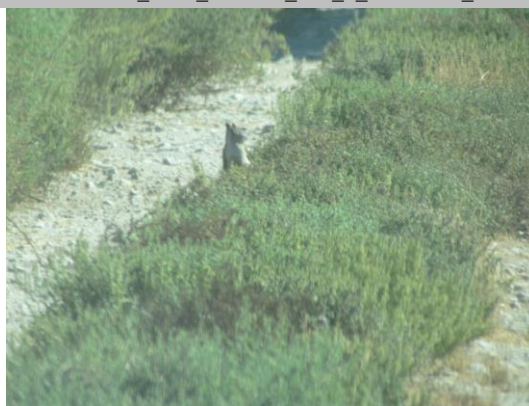
Photo 1 of 1 : SP_2019_NA0011_144_8_20190307_00011.jpg

LM Start	0.71	Rating **	M	Issue No.	8
LM End	1.51	Issue Type +	Ma	Location *	CR
Category	Earthen Levee			GPS Latitude/Longitude	
				Start	End
Item	Animal Control			36.996257 °	36.996607 °
				-120.361025 °	-120.346568 °
DWR ID	DWR_NA0011_03_f_2016_8				
Comment Code					
A1 : Exterminate rodents and backfill and compact or grout burrows.					
Inspector Comment					
Exterminate rodents from the roadway. Active rodents observed during inspection at this site.

Berenda Slough Unit 3 looking upstream from levee miles 0.71 - to 1.51.

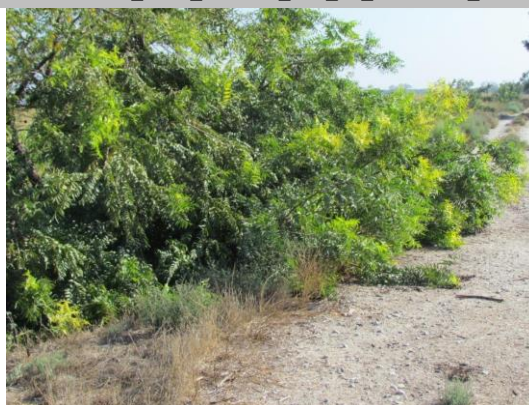
Photo 1 of 1 : SP_2019_NA0011_144_11_20190307_00015.jpg

LM Start	1.04	Rating **	U	Issue No.	11
LM End	1.05	Issue Type +	Ma	Location *	LS
Category	Earthen Levee			GPS Latitude/Longitude	
				Start	End
Item	Trim / Thin Trees			36.996613 °	36.996610 °
				-120.355055 °	-120.354995 °
DWR ID	DWR_NA0011_03_s_2012_11				
Comment Code					
T1 : Trim trees to at least five feet above ground level.					
Inspector Comment					
Remove nut tree from the slope.

Walnut trees blocking the view of the landside levee section.

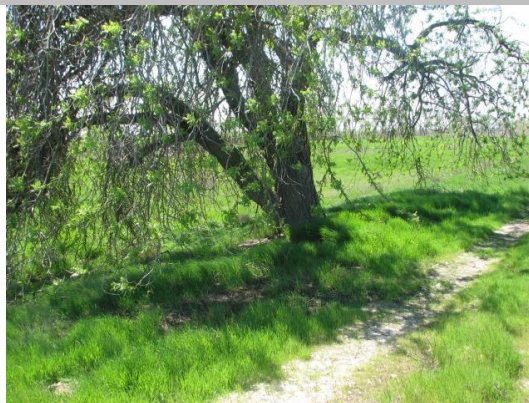
Photo 1 of 1 : SP_2019_NA0011_144_14_20190307_00017.jpg

LM Start	1.09	Rating **	U	Issue No.	14
LM End	1.09	Issue Type +	Ma	Location *	WS
Category	Earthen Levee			GPS Latitude/Longitude	
				Start	End
Item	Trim / Thin Trees			36.996618 °	36.996618 °
				-120.354307 °	-120.354307 °
DWR ID	DWR_NA0011_03_s_2017_14				
Comment Code					
T2 : Thin trees to allow visibility of the ground and room to flood fight.					
Inspector Comment					
Branches hanging over crown are beginning to obstruct access.

Looking at untrimmed tree on waterward shoulder. (Spring 2018)

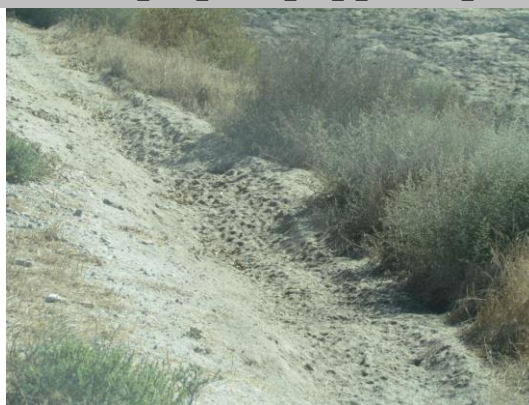
Photo 1 of 1 : SP_2019_NA0011_144_4_20190307_00003.jpg

LM Start	1.24	Rating **	M	Issue No.	4
LM End	1.25	Issue Type +	Ma	Location *	CR
Category	Earthen Levee			GPS Latitude/Longitude	
				Start	End
Item	Slope Stability			36.996582 °	36.996582 °
				-120.351482 °	-120.351258 °
DWR ID	DWR_NA0011_03_f_2016_4				
Comment Code					
S1 : Repair slope instability.					
Inspector Comment					
Repair the slope instability and damaged shoulder at this location.

Berenda Slough looking back upstream waterside at the shoulder and slope.

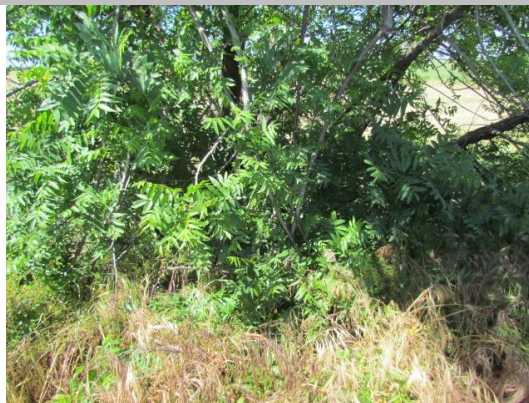
Photo 2 of 2 : SP_2019_NA0011_144_17_20190307_00019.jpg

LM Start	1.24	Rating **	U	Issue No.	17 (cont)	
LM End	1.29	Issue Type +	Ma	Location *	LS	
Category	Earthen Levee			GPS Latitude/Longitude		
				Start		End
Item	Trim / Thin Trees			36.996632 °		36.996600 °
				-120.351463 °		-120.350539 °
DWR ID	DWR_NA0011_03_s_2012_17					
Comment Code						
T2 : Thin trees to allow visibility of the ground and room to flood fight.						
Inspector Comment						
Remove nut trees from the landside slope.

Looking upstream from landside slope tree has blocked view of the slope and shoulder.

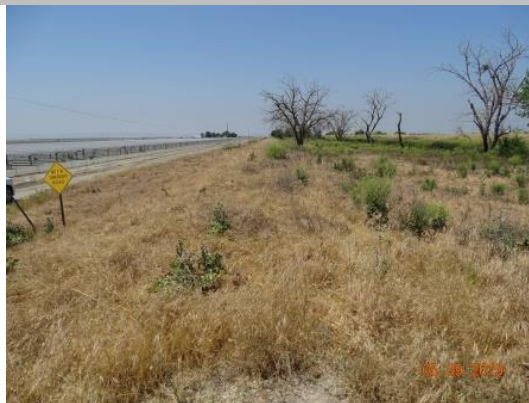
Photo 1 of 2 : SP_2019_NA0011_145_8_20190514_00030.jpg

LM Start	0.01	Rating **	U	Issue No.	8
LM End	1.49	Issue Type +	Ma	Location *	CR
Category	Earthen Levee			GPS Latitude/Longitude	
				Start	End
Item	Vegetation			36.995503 °	36.995580 °
				-120.373417 °	-120.346588 °
DWR ID	DWR_NA0011_04_s_2017_8				
Comment Code					
V9 : Keep the crown roadway free of vegetation.					
Inspector Comment					
Keep the crown roadway free of vegetation.

Looking downstream from LM 1.49 at vegetation on levee crown. (Spring 2019)

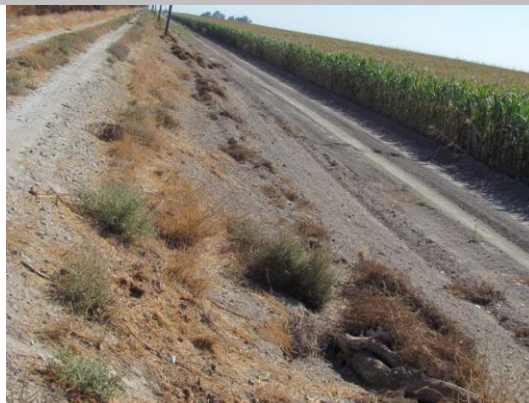
Photo 1 of 1 : SP_2019_NA0011_145_3_20190307_00001.jpg

LM Start	0.02	Rating **	U	Issue No.	3
LM End	0.97	Issue Type +	Ma	Location *	LS
Category	Earthen Levee			GPS Latitude/Longitude	
				Start	End
Item	Slope Stability			36.995506°	36.995550°
				-120.373233°	-120.355935°
DWR ID	DWR_NA0011_04_f_2016_3				
Comment Code					
S1 : Repair slope instability.					
Inspector Comment					
The slope in this area has been damaged by farm equipment.

Berenda Slough Unit 4 Looking upstream from levee mile 0.14-0.97.

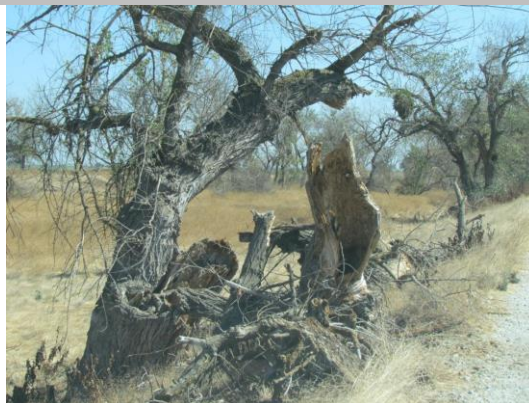
Photo 1 of 1 : SP_2019_NA0011_145_15_20190307_00014.jpg

LM Start	0.14	Rating **	U	Issue No.	15
LM End	0.14	Issue Type +	Ma	Location *	WS
Category	Earthen Levee			GPS Latitude/Longitude	
				Start	End
Item	Encroachments			36.995528 °	36.995528 °
				-120.370922 °	-120.370922 °
DWR ID	DWR_NA0011_04_f_2015_15				
Comment Code					
TR : Tree or limb					
Inspector Comment					
There are many dead trees in the area. Remove the dead trees from the levee section. Many more are subject to fall and possibly block access to the levee crown.

Berenda Slough looking upstream from the levee mile 0.14.

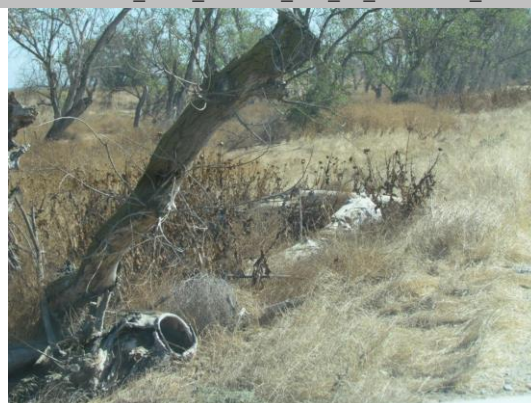
Photo 1 of 1 : SP_2019_NA0011_145_16_20190307_00015.jpg

LM Start	0.47	Rating **	M	Issue No.	16
LM End	0.47	Issue Type +	Ma	Location *	WS
Category	Earthen Levee			GPS Latitude/Longitude	
				Start	End
Item	Encroachments			36.995603 °	36.995603 °
				-120.364978 °	-120.364978 °
DWR ID	DWR_NA0011_04_s_2014_16				
Comment Code					
TR : Tree or limb					
Inspector Comment					
This dead tree on the waterward slope should be removed from the levee section.

Tree on WS shoulder.

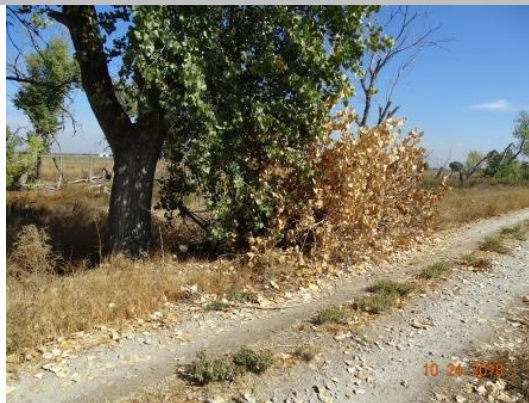
Photo 1 of 1 : SP_2019_NA0011_145_32_20190307_00025.jpg

LM Start	0.72	Rating **	M	Issue No.	32
LM End	0.72	Issue Type +	Ma	Location *	WS
Category	Earthen Levee			GPS Latitude/Longitude	
				Start	End
Item	Trim / Thin Trees			36.995577 °	36.995577 °
				-120.360438 °	-120.360438 °
DWR ID	DWR_NA0011_04_f_2018_32				
Comment Code					
T1 : Trim trees to at least five feet above ground level.					
Inspector Comment

Trim branches on waterside shoulder. (Fall 2018)
